Reconstruction of an Office Building, Roosevelt Square, Budapest

Jozsef Almasi, Dr, Managing Director; Balint Nemes, Msc, Eng., Cronauer Almasi Engineering Consulting, Budapest, Hungary

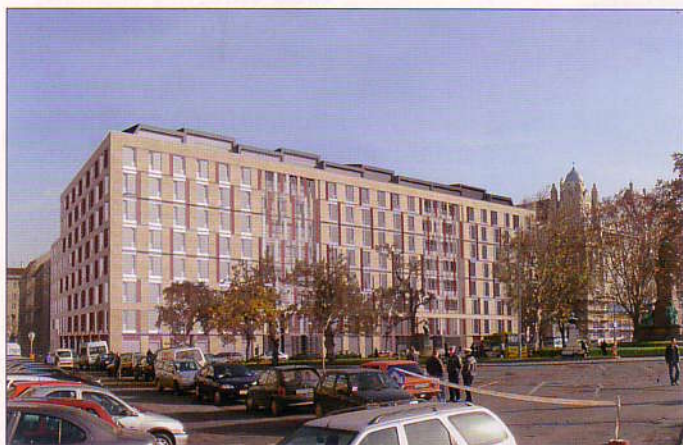
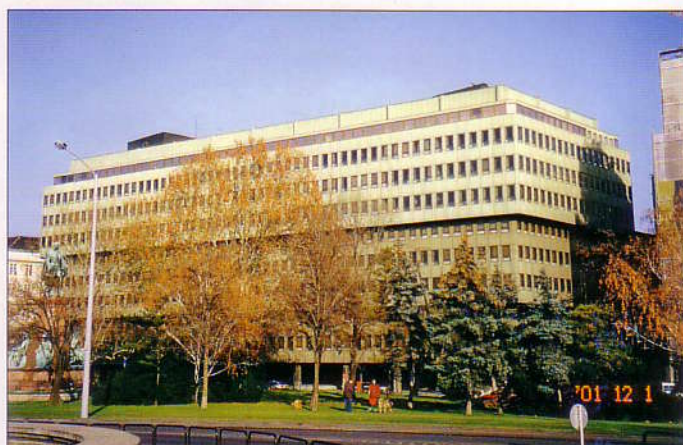
Fig. 1: The office building before and after reconstruction

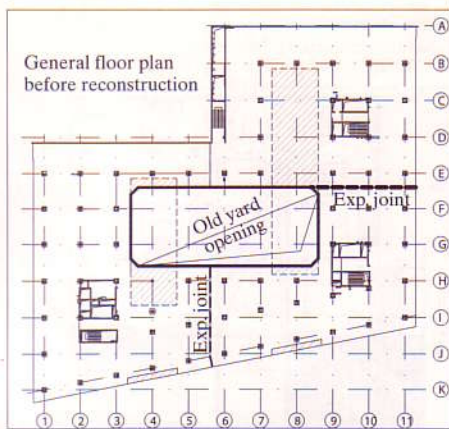
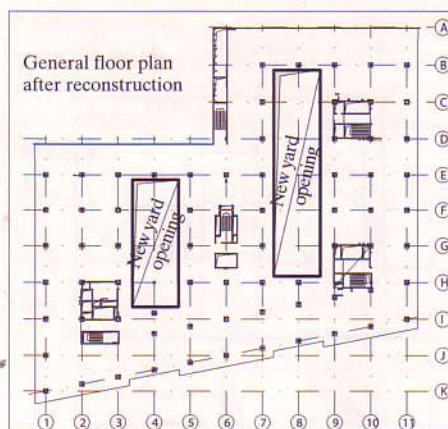
The expansion joints divided the original building into three parts; each building part had a stiffening core, as shown in Fig. 2. The strength of these cores was reduced by new openings, so the horizontal stability of each part was decreased.

Fig. 2: Reconstruction of general slab

The existing expansion joints “crossed the new building section” which was designed in the middle of the old yard, and so it was not possible to keep the expansion joints in the same place. To make new expansion joints would cause instability of the structures. But by closing the expansion joints, global stability of the building could be increased. Therefore, it was decided to close the existing expansion joints by cutting back a part of the old concrete slab and by putting additional reinforcement in, before new concrete was laid. The design philosophy was that the largest movement had been coming from shrinkage and this was over the past 30 years. Within the finished building which measures 70×80 m the movement from temperature is very small, and can be absorbed by the structure.

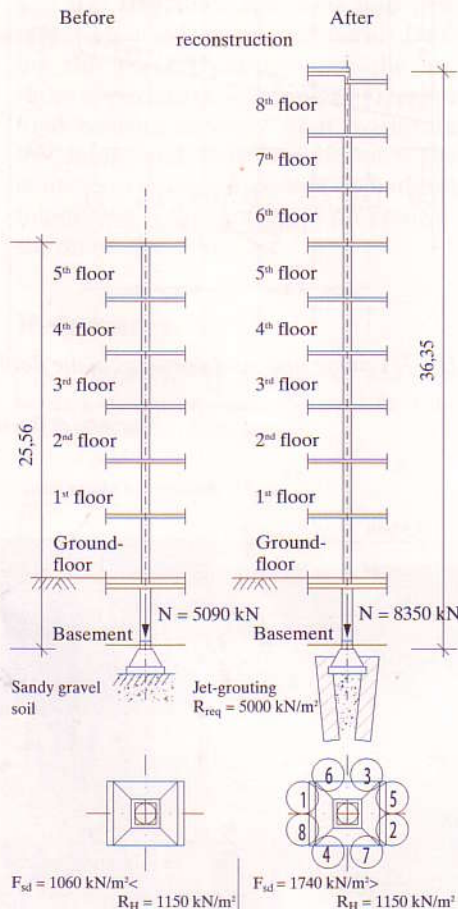
Fig. 3: Increasing the load bearing capacity of existing foundations

Because of these modifications, it was necessary to strengthen some of the foundations by injection grouting and strengthening the columns using the FRP wrap system. “Jet-grouting columns” were designed with a diameter of 80 cm and with a length of $5,0 \text{ m}$. The control measurements for the soil strength showed 5000 kN/m^2 , and $1,5 \text{ mm}$ settlement (Fig. 3).

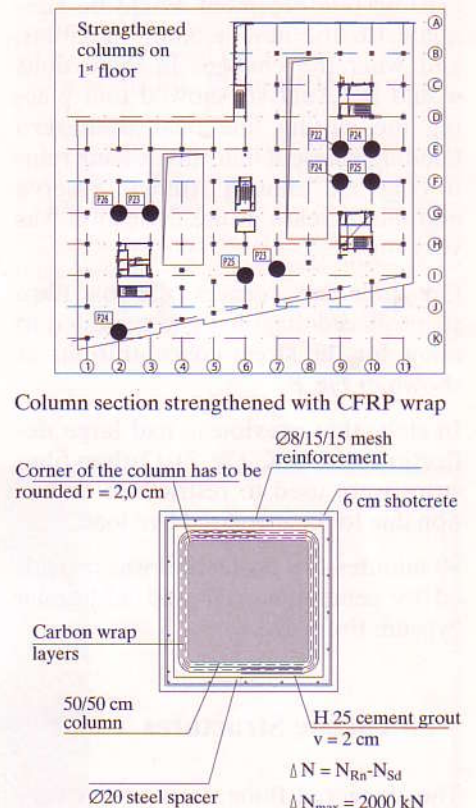
Fig. 4: Increasing the load bearing capacity of existing columns

The number of FRP wrap sheets varied from one to four layers. The design increase of maximum load bearing capacity depended on required increased loading. The maximum increase of the

load bearing capacity was 2000 kN for one column with a 50×50 cm cross-section and C20 concrete strength originally. The FRP was given 6 cm thick fire protection from shotcrete, as shown in Fig. 4.

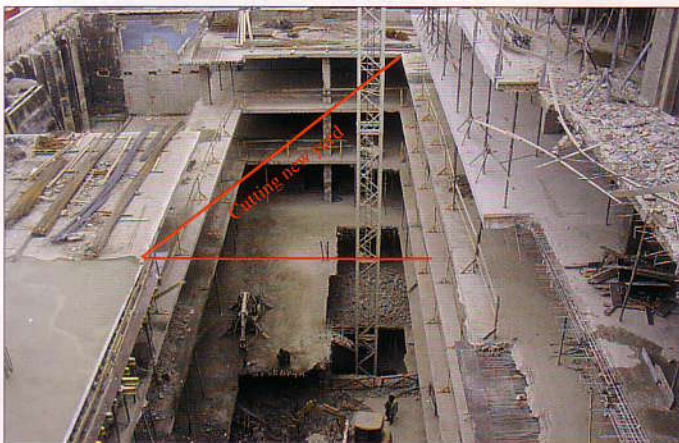
Fig. 5: Cutting new yards openings on the floor slabs

To achieve a more functional building the architect proposed to close the old yard and make two new yards by cutting through the existing floor slabs, as shown in Figs. 5, 6, 7. These “simple geometrical transformations” resulted in new boundary conditions for the slabs. The question was, whether the existing reinforcement would be adequate for the new bending moments, and what the changes in deflections would be. Analysis showed that placing the cutting line near to a zero bending moment line, the existing reinforcing had enough strength reserve and the increase in the deflection was very small.

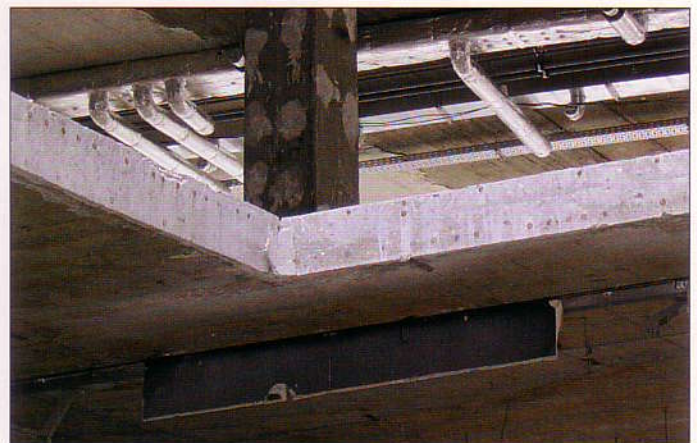
Fig. 6: Reinforcement in existing slab at cutting edge

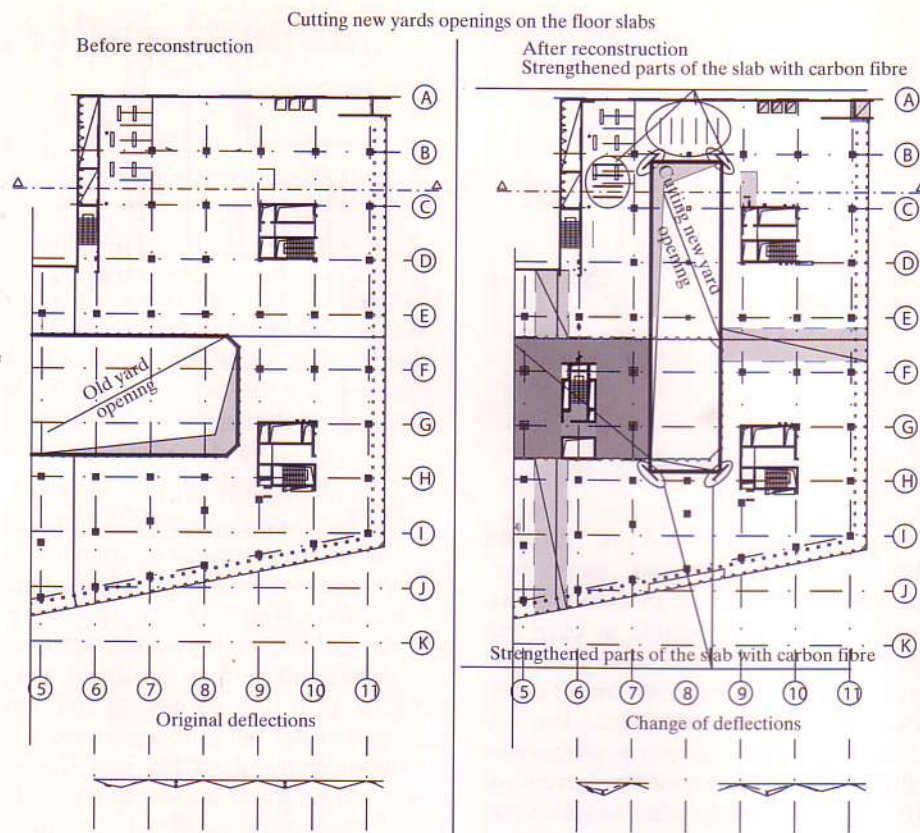
Fig. 7: Cutting new yard openings in the floor slab

In slabs that previously had large deflections (1-2/J-K, Fig. 7), Carbon fibre strips were used to restrict the deflection due to the increased live load.

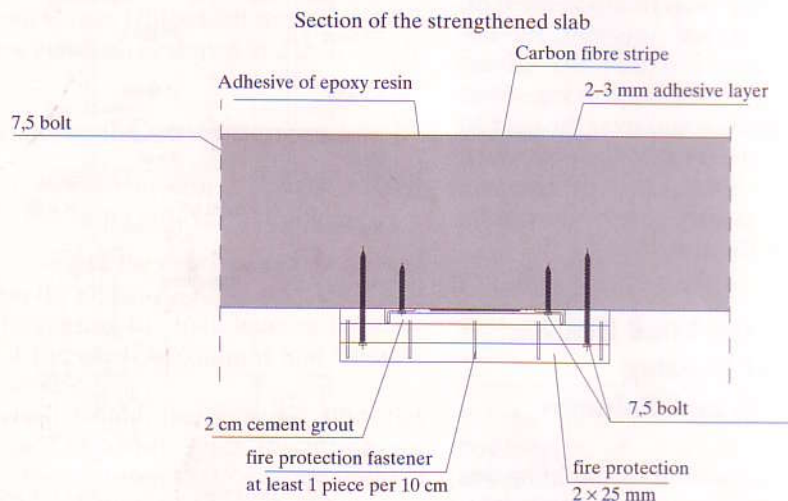
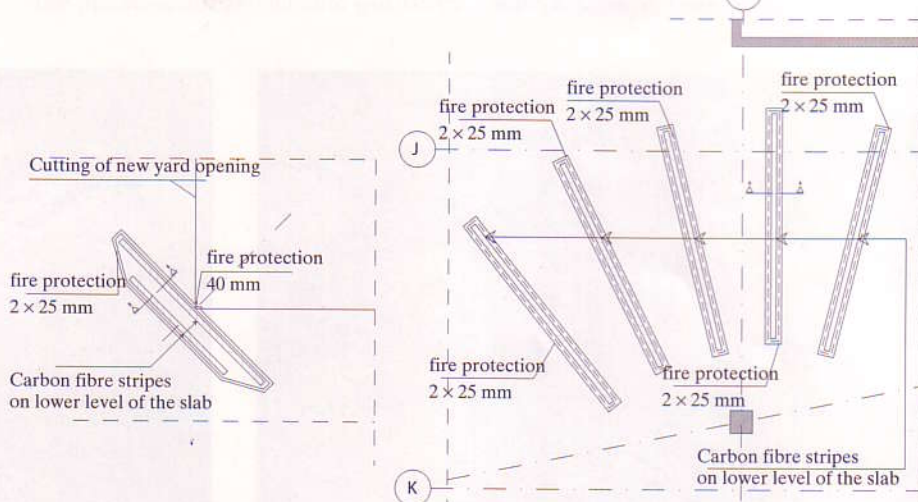
Layout details of the strengthened slab

Fig. 8: Details of slab strengthened with carbon fibre stripes

On some cut corners, Carbon fibre strips placed diagonally were added to allow for the stress concentrations as shown in Fig. 8.

90 minutes fire protection was provided by cement mortar and additional gypsum fireboard.

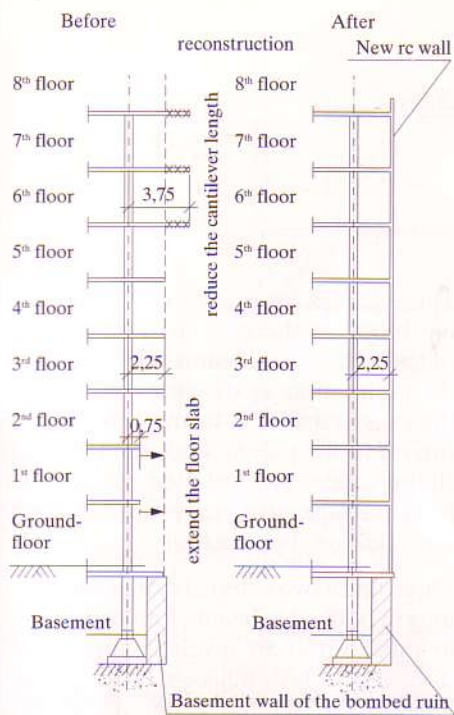
Fig. 9: The old and new facade structure

To follow the architectural concept of the new facade on the upper floor slabs it was necessary to reduce the overhang of the slabs, and at lower floor slabs to extend them, as shown in Fig. 9.

To improve heat insulation and to be able to build a modern facade a new concrete wall was designed, which was supported on the foundation of an earlier building which existed before the Second World War, and until now had been covered by the pavement. This new reinforced concrete (RC) wall gives support to the floor slabs.
